Assessment of the Effectiveness of the Israel River Ice Control Structure, Lancaster, NH

Carrie M. Vuyovich and Kathleen D. White

January 2006

**Cold Regions Research
and Engineering Laboratory**

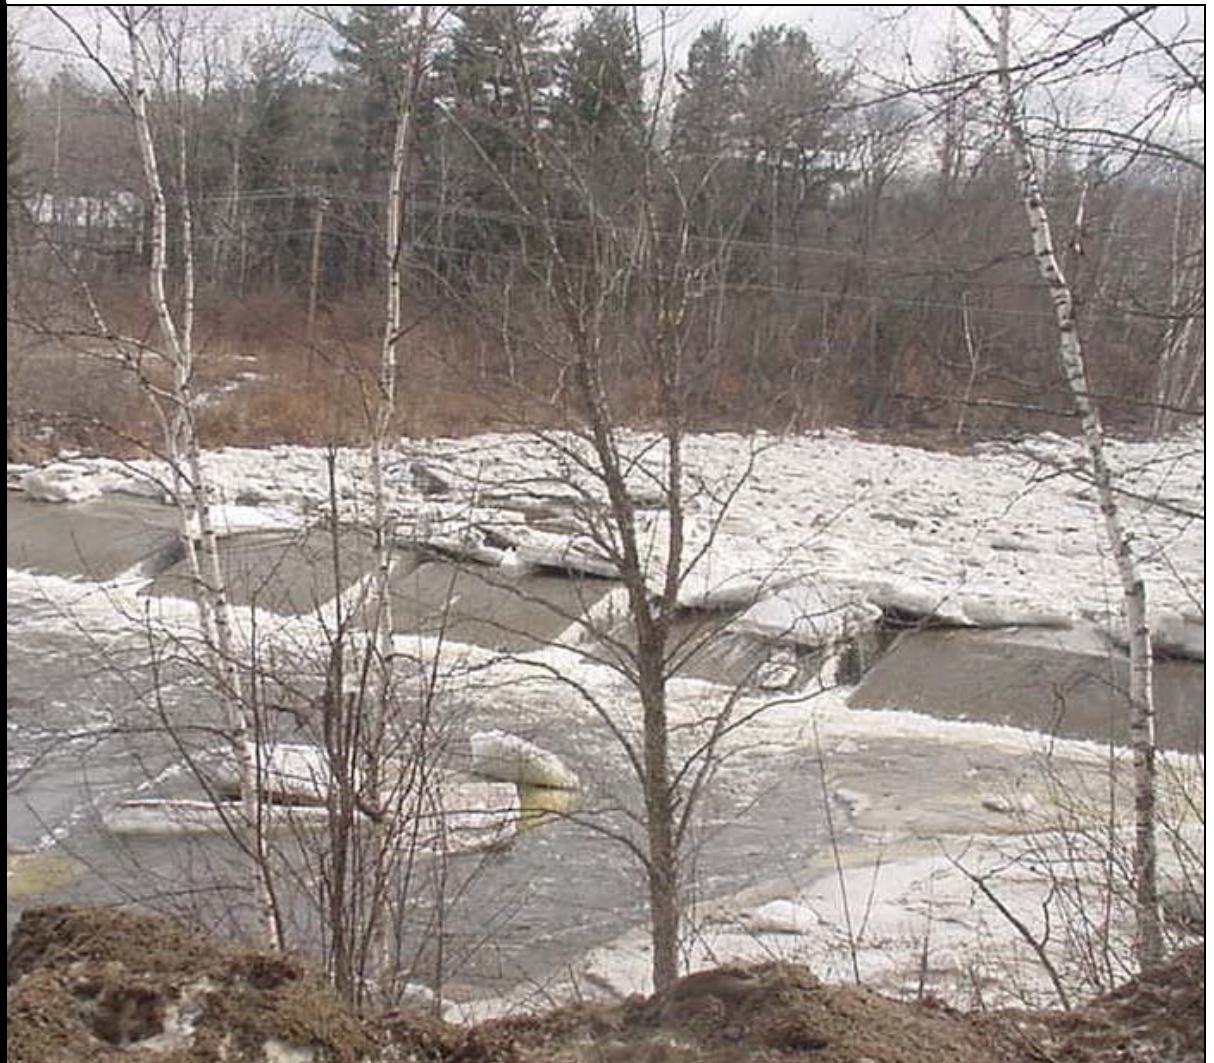
Cover: Ice cover retained upstream of the ICS during the 24 March 2003 ice event.

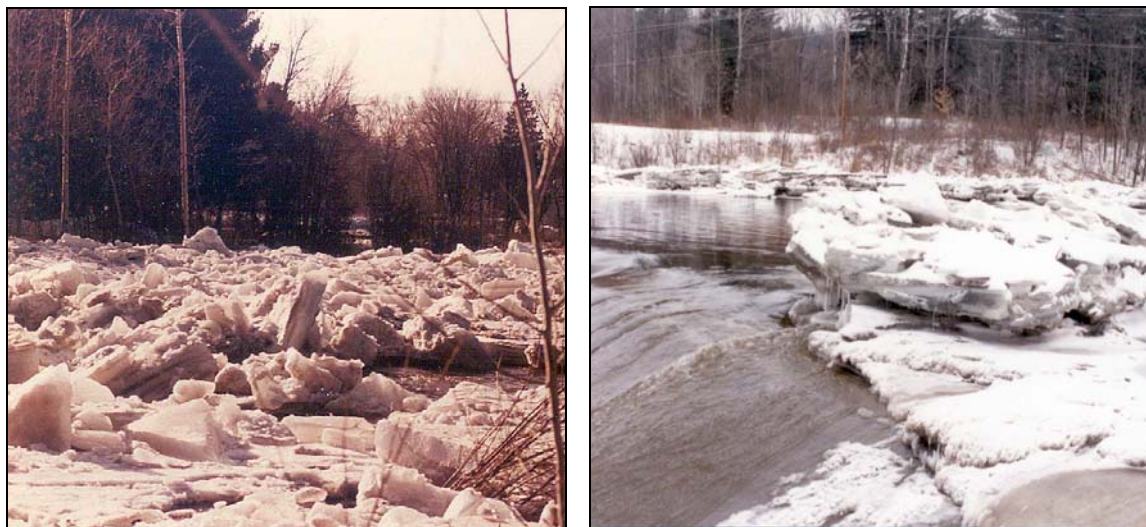
Figure 3. Ice retention upstream from the ICS during ice jams.

a. Ice jam in the ICS pool, February 1985.

b. Ice above the weir, March 12, 1992.

large enough to break up the ice and lift it over the ICS. Figure 3 shows the February 1985 and March 1992 jamming upstream from the ICS.

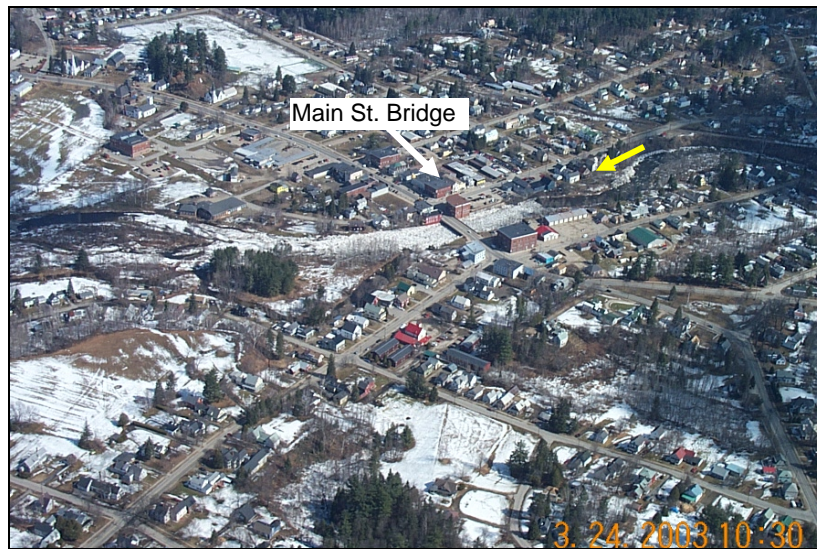
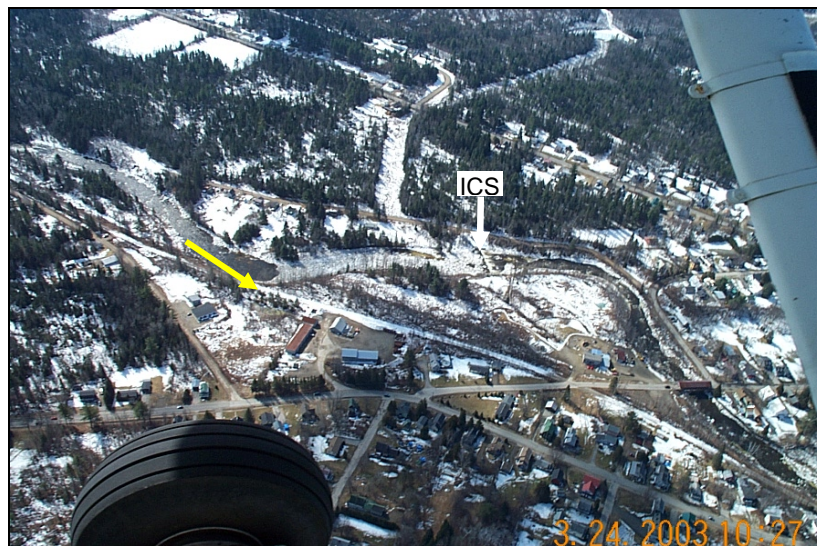
Figure 6. Aerial photos of the 24 March 2003 ice event. The yellow arrows indicate the flow direction.

sequence of ice movement over the ICS and jam failure in town indicate that the discharge required to pass ice over the ICS may be close to the discharge associated with failure of the jam in town. A detailed hydraulic analysis of the reach, including a rating curve for the ICS, is necessary to confirm this. The cover photograph captures incipient conditions for ice passage over the ICS.

a. Ice jam in town.

b. Ice held above the ice control structure.

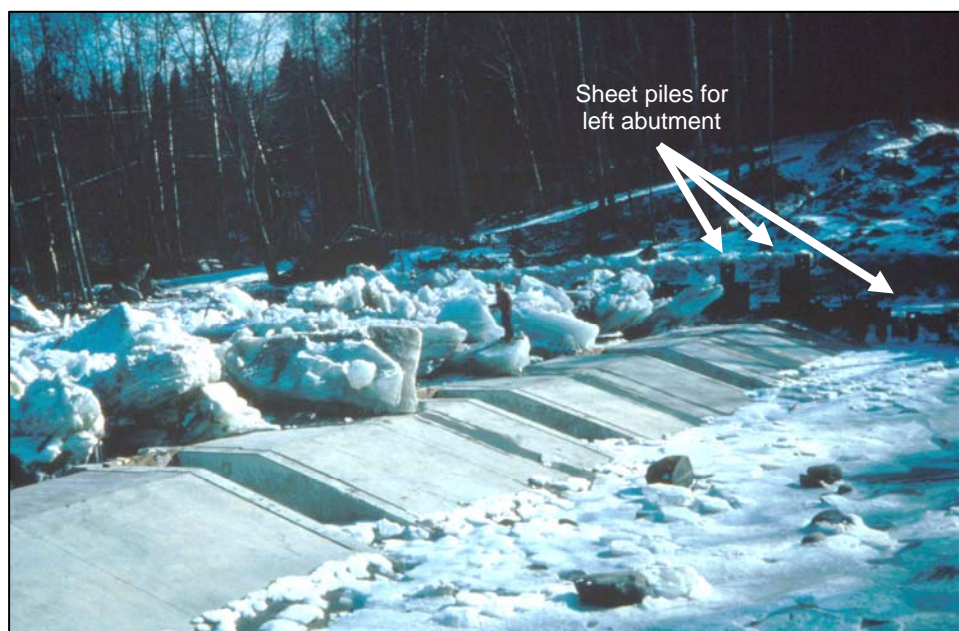
**Figure 10. Ice retention upstream from the ICS during construction, winter 1980-81.**

During this period, which spans 1981 through 1990, Table 3 predicts three severe ice jams: in 1981, 1989, and 1990. In 1981, significant amounts of ice were retained upstream from the ICS (Fig. 10). As noted previously, field notes report significant volumes of jammed ice in the river extending as far up as the covered bridge. At the same time, the ICS retained ice from upstream. If this ice had not been retained, it would have pushed downstream and added to the volume of ice already jammed, thickening the jam, possibly to similar proportions as in 1968, 1950, and 1970. Ice was reported jammed up to the covered bridge in the 1989 event, and that upstream ice was held above the ICS. In 1990

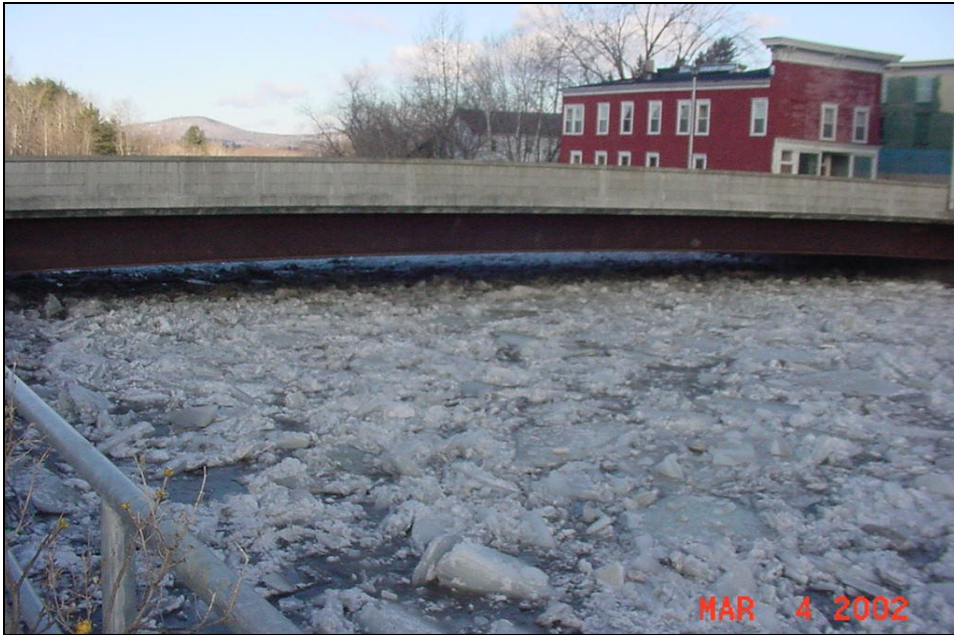
Figure 11. Ice jam of 4 March 2002 (looking downstream toward the Main Street Bridge).

Two jams were identified as being potentially severe after the ICS was in place, but were not. In 2002, an ice jam occurred on 4 March, about a week before the predicted jam shown in Table 3. Ice was retained above the ICS. That year, the ice was thought to be weaker and thinner than predicted by the Stefan equation because of a melt event recorded on 12 February. This allowed breakup to occur at a lower discharge than normal, and, while causing a relatively high stage (Fig. 11), the jam remained in place only for a matter of hours. Thus, the larger flow identified in Table 3 occurred during open-water conditions on the Israel River in Lancaster. In the spring of 2004, a smaller jam was recorded by the monitoring equipment on 27 March, about a week prior to the event predicted by the threshold criteria. The jam caused a stage increase of about 4 ft at the measuring site, and it remained in place until 30 March, with a little shove on 29 March.

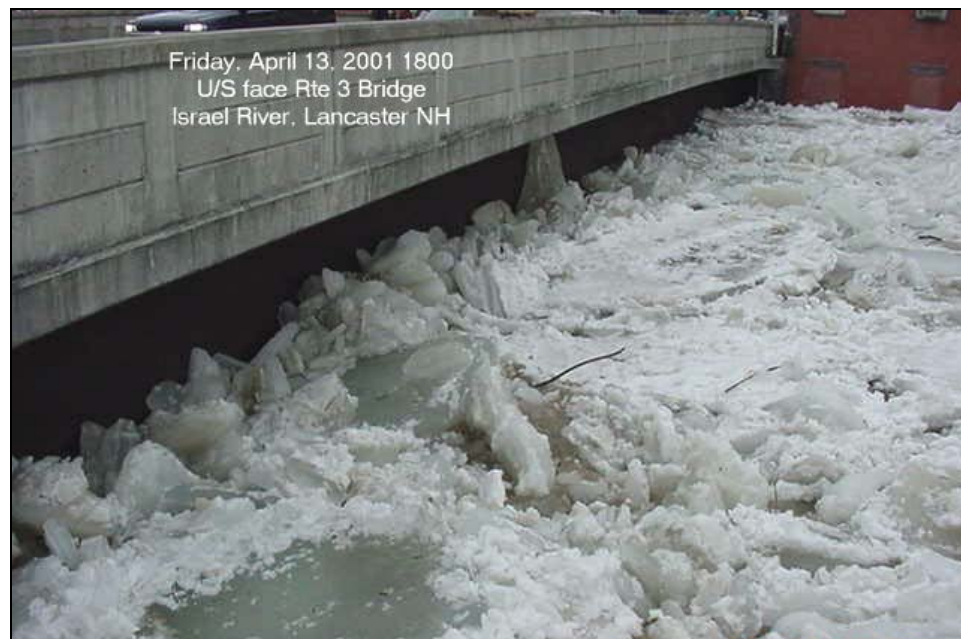
Figure 14. Ice building up on the upstream face of the single-span Main Street Bridge in April 2001. (From USA CRREL Ice Jam Database.)

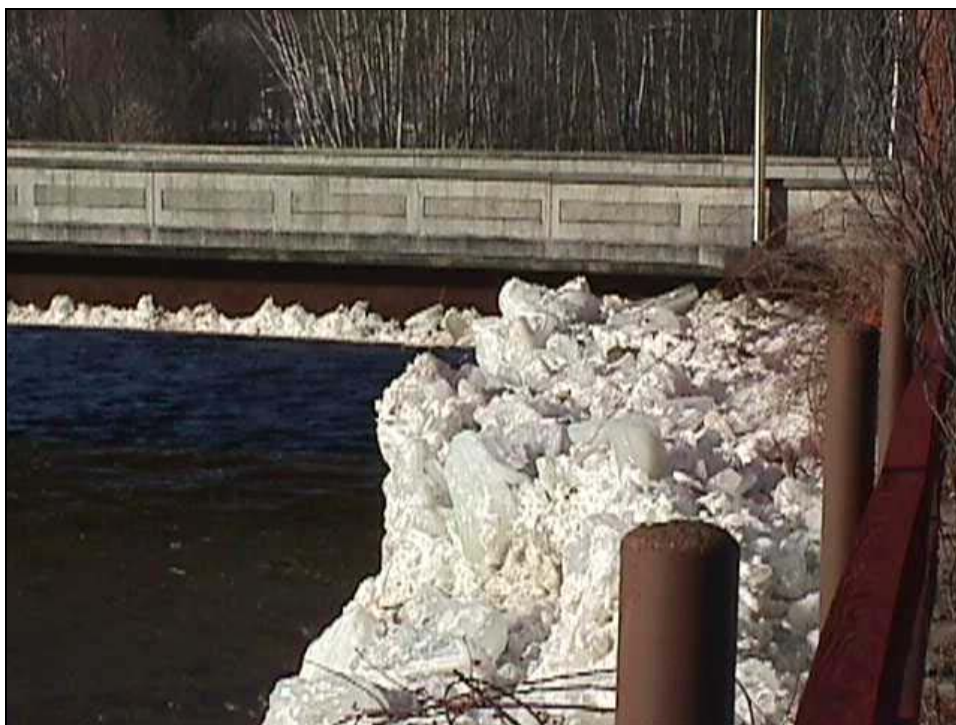
Figure 15. Upstream view of the Main Street Bridge after the ice jam of January 1999. (Photo courtesy of Greatnorthwoods.org, <http://www.greatnorthwoods.org/lanaster/icejam19990124/1/>.)
